Reference: a) DTCG85-00-D-66P381 Polar Class Icebreaker Grooming Contract
b) IOS Job 7-2963-036, Delivery Order D034 - Clin 0018

Subject: Healy Groom Feb 2006

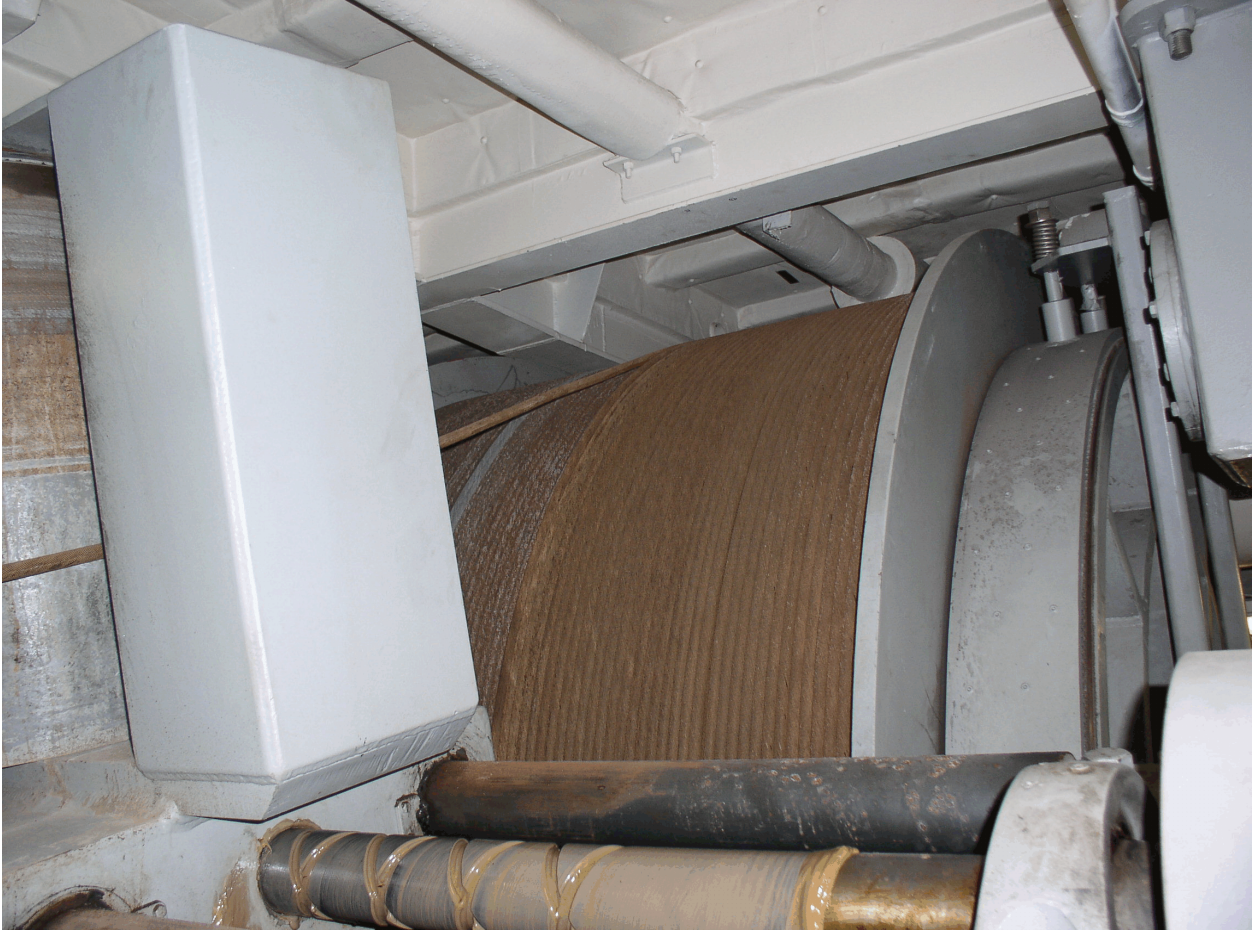
There were no CFR's to process. However, as evidenced in the attached photo of the 0.680 EM cable, there is considerable rust on this cable. Before the next deployment that will make use of this cable, it should be closely inspected and replaced if necessary.

Heavy rust on 0.680 EM Cable
